City of Wanneroo Coastal Monitoring Report October 2024

1 Introduction

1.1 Coastal Foreshore Monitoring

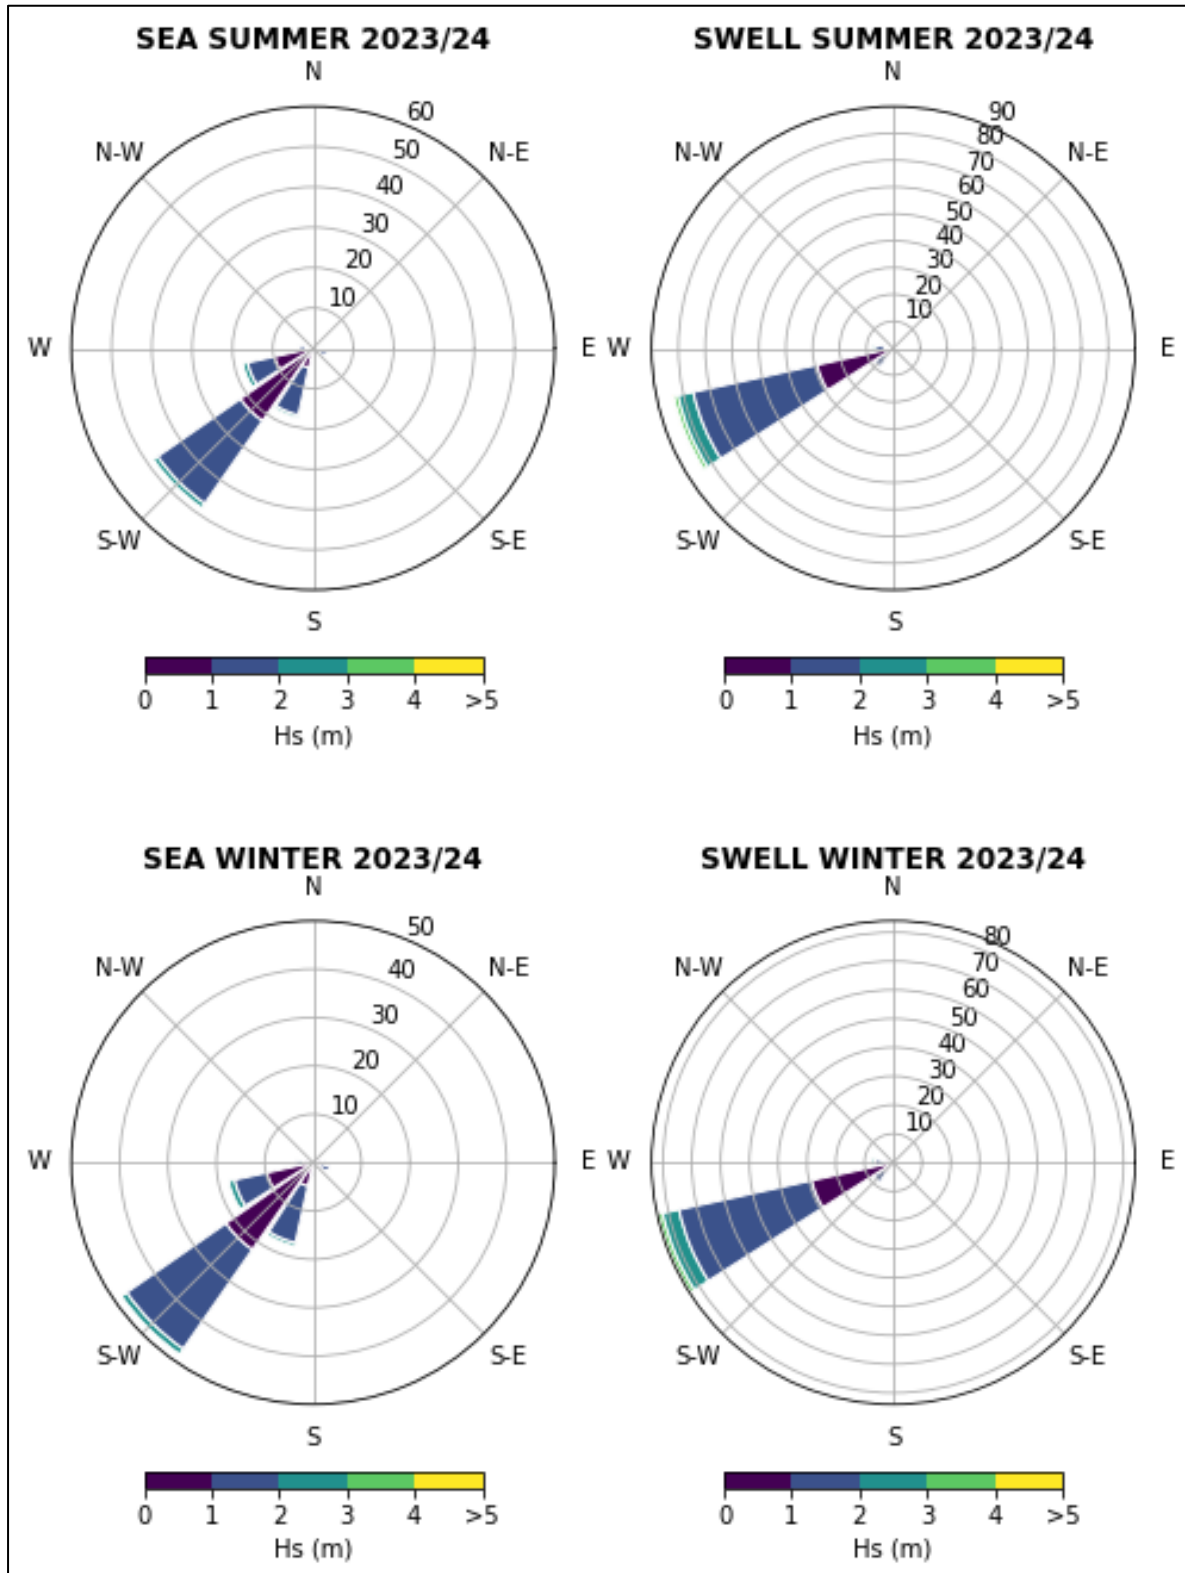
Figure 2-7 Wind rose plots of sea and swell significant wave heights from the summer season (October 2023 to March 2024) and the winter Season (April to September 2024)

As seen in Figure 2-7, the wave climate for both the summer and winter periods is characterised by west south westerly waves and as expected, there is an increase in swell height during winter period. Notably, for this study period, wave direction remained consistent for most of the year, with less than 15% readings captured outside of the consistent west south westerly direction.

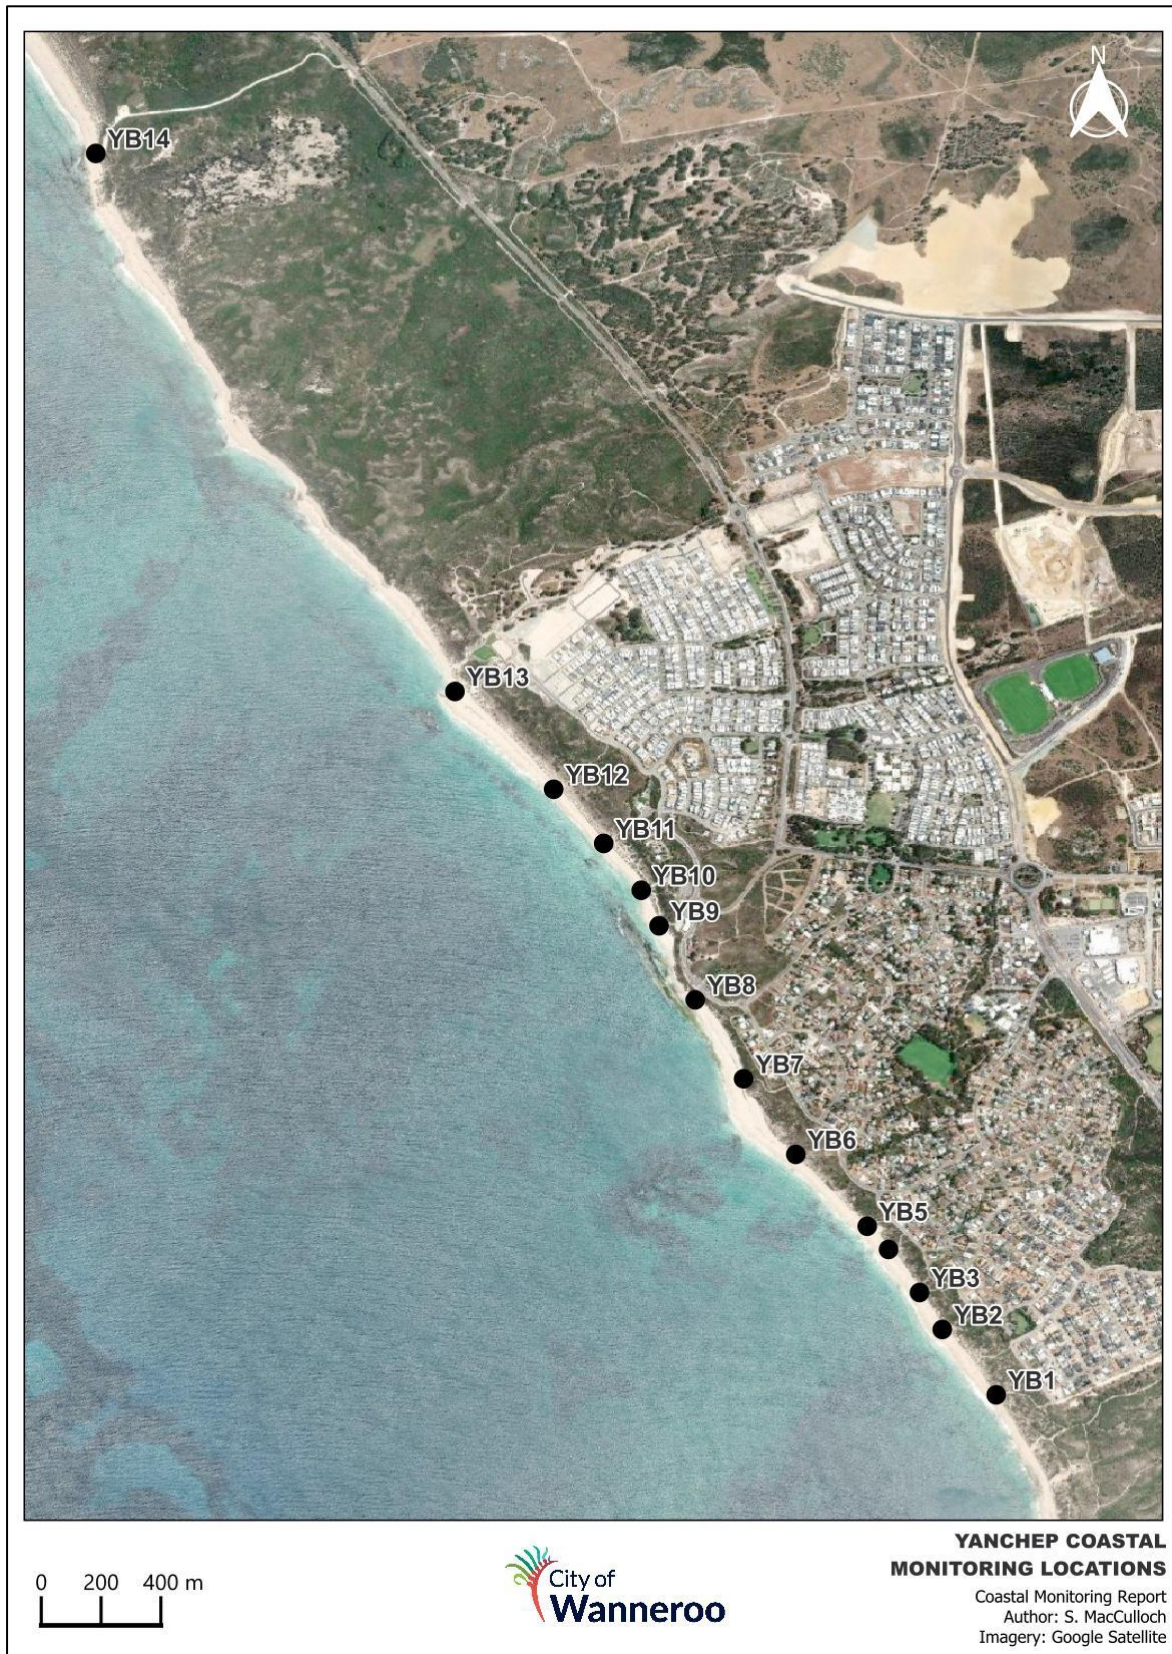
Figure 4-2 Yanchep Coastal Monitoring Locations

There are a total of 52 manual imagery beach monitoring sites located in key vulnerable coastal areas along the CoW coastline. The positions of these sites are presented in Figure 4-1 to Figure 4-6. Images are taken biannually in April and October each year to assess seasonal and long-term changes to beach morphology. The October 2024 images are taken by JB Pacific's Coastal Engineer and are taken at the same location and with same field of view as previous years. A detailed description of the methodology for obtaining manual images is outlined in the Coastal Monitoring Inspection Manual CM (Ref #22/89708).

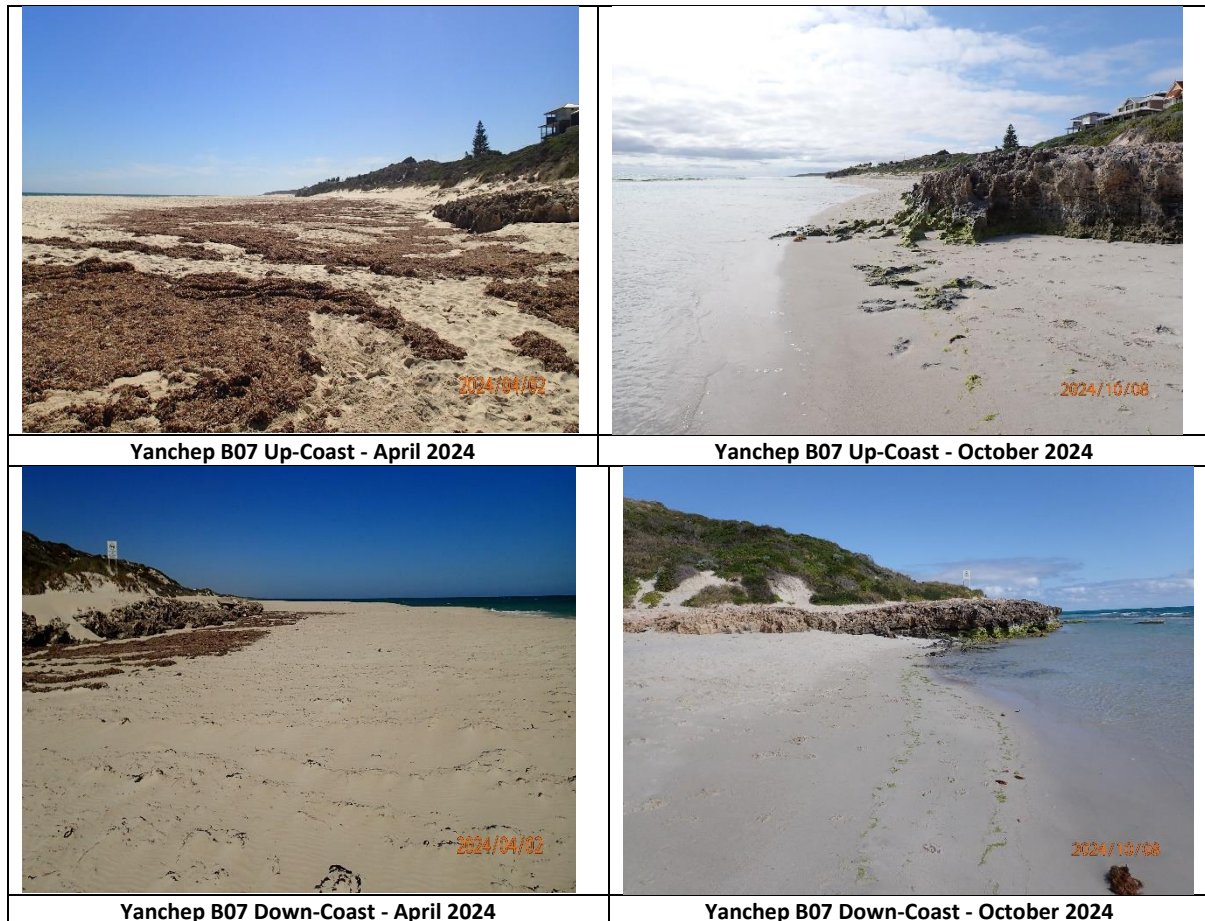
4.2.1.1 Yanchep B07 Up-Coast and Down-Coast – Major Erosion, Winter 2024

Figure 4-7 Major erosion over winter 2024 at Yanchep B07.

The beach captured in the photographs taken Up-Coast and Down-Coast at the Yanchep monitoring location B07 is bounded by a headland to the north. There was a significant reduction in beach width over the 2024 winter period with the transport of sediment southward over the winter months resulting in erosion to the north of the headland. Subsequently, however, northward movement of sediment during the summer months results in significant accretion at the site which provides a substantial buffer against early winter storms. While there is major seasonal variation at the site, the long-term assessment suggests that the site has experienced notable reduction in beach volume and height since the start of monitoring in 2019. It is important to note, however, that residential houses and road infrastructure are in close proximity to the site and could, in future, be susceptible to the effects of coastal erosion and it is therefore recommended that the site be monitored closely.

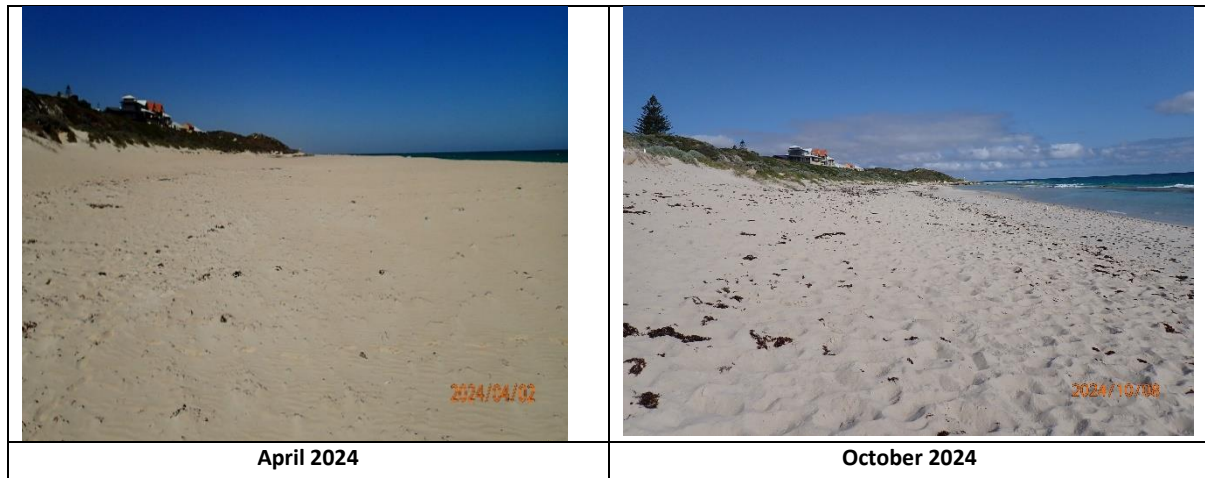
4.2.1.2 Yanchep B08 Down-Coast – Major Erosion, Winter 2024

Figure 4-8 Major erosion over winter 2024 at Yanchep B08 Down-Coast.

The Down-Coast photograph taken at Yanchep site B08 captures the same stretch of coastline captured in the Up-Coast photograph taken at Yanchep site B07 as discussed above in Section 4.2.1.1. Yanchep photograph site B08 is situated immediately south of the headland and southward sediment transport over winter 2024 results in erosion at Yanchep site B08.

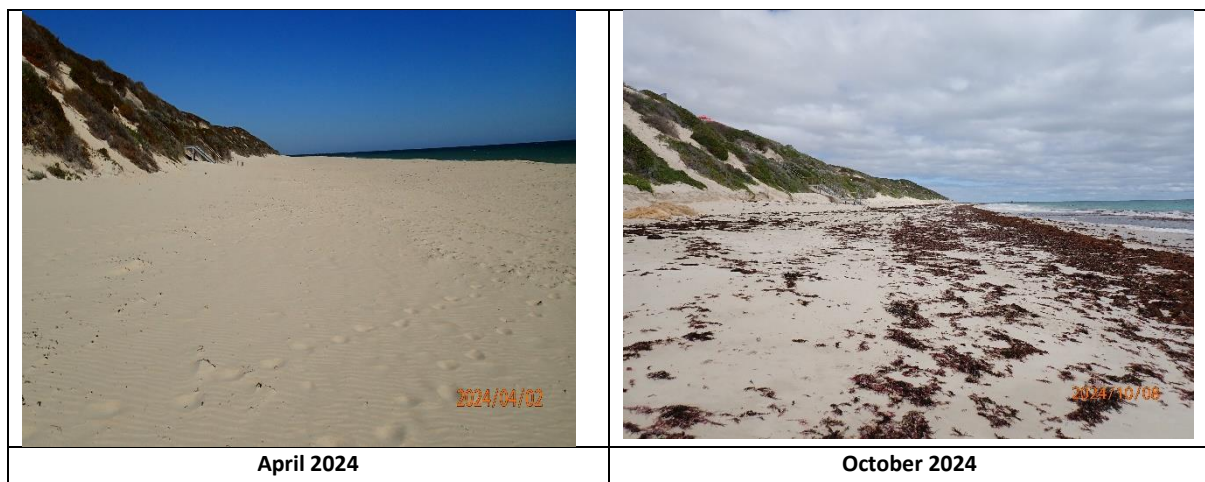
4.2.1.3 Amberton B01 Down-Coast – Major Erosion, Winter 2024

Figure 4-9 Major erosion over winter 2024 at Amberton B01 Down-Coast.

Significant seasonal erosion with reduction in beach width and erosional scarp at the toe of dune is noted at Down-Coast of Amberton Beach B01 over winter 2024. A Mid-term assessment (2021-2024) of beach also suggests a minor reduction in beach width and erosion at the base of dune compared to the photos taken during October 2021.

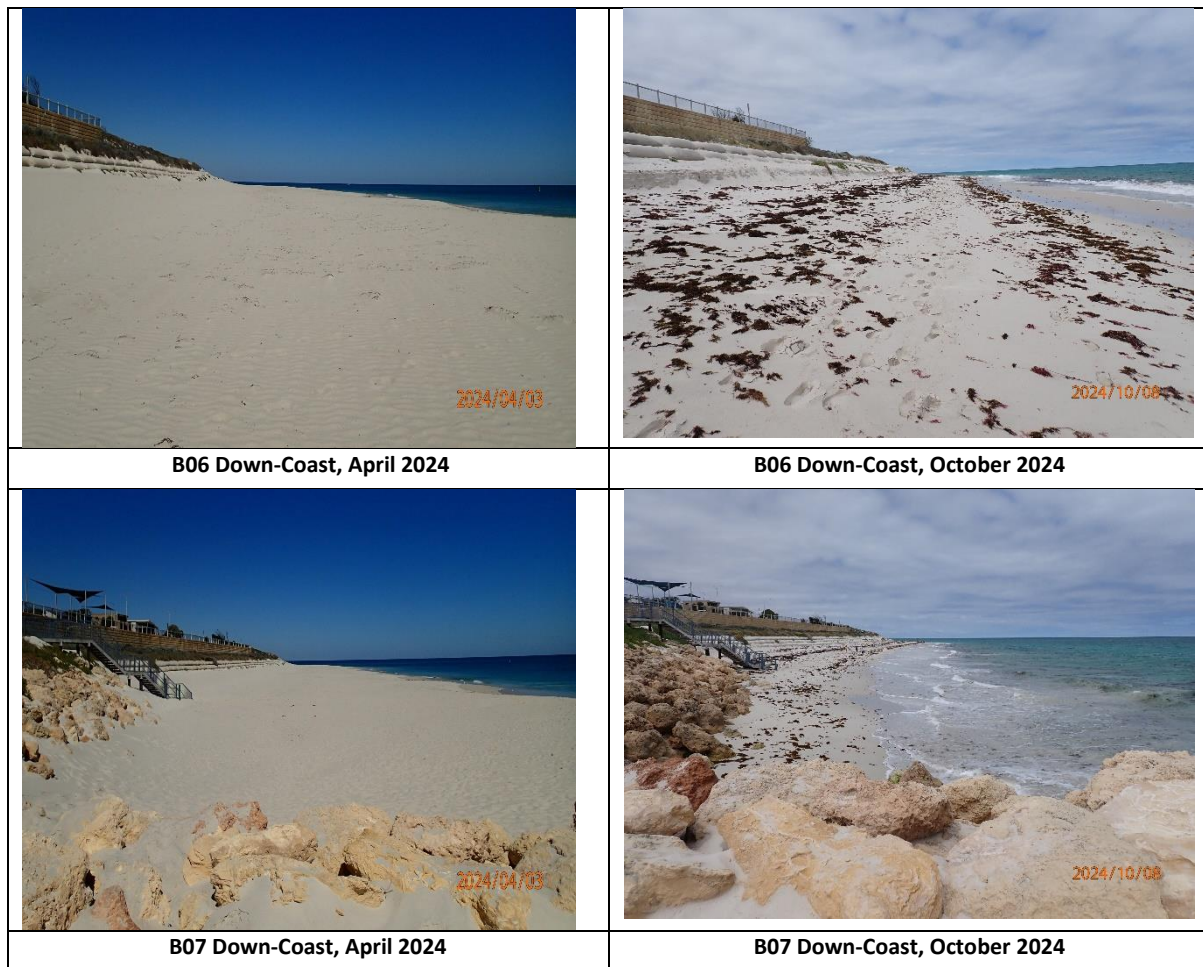
4.2.1.4 Quinns Rocks B06 and B07 Down-Coast – Major Erosion, Winter 2024

Figure 4-10 Major erosion over winter 2024 at Quinns Rocks Rock B06 and B07 Down-Coast.

A significant reduction in beach width is observed south of Quinns Rocks Groyne One (1) over the 2024 winter period. This is also a result of the southward movement of sediment over the winter period. While the erosion is significant, the coastal management measures implemented at the site including the GSC revetment mean that it is unlikely to be of short-term concern.

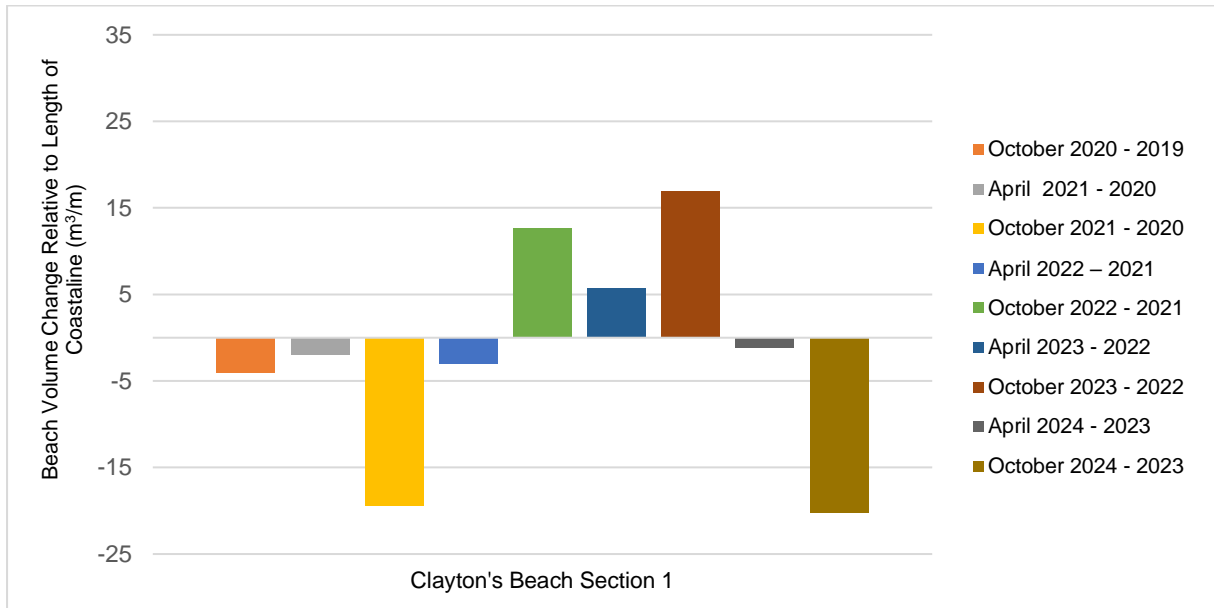
Figure 5-1 Annual net beach volume changes for Clayton's Beach Section 1.

The Clayton's Beach Section 1 is situated immediately south of the Mindarie Marina Breakwater, which interrupts the northward longshore sediment transport, trapping sand within the beach section defined by Clayton's Beach Section 1. Figure 5-1 shows that the increase in beach volume along Clayton's Beach observed between October 2021 and October 2023 has been followed by significant erosion over the past year. The net beach volume gain observed during the study periods October 2021 to 2022, April 2022 to 2023 and October 2022 to 2023 is likely attributed to strong sea breezes observed throughout the seasonal summer period. Over the 2023/2024 period there has been an increase in annual net beach volume of 13,194 m³ in the nearshore section (Clayton's Beach Section 1B), as presented in Table 5-2. However, significant erosion was observed above the water line with annual net beach volume change of -38,783 m³.

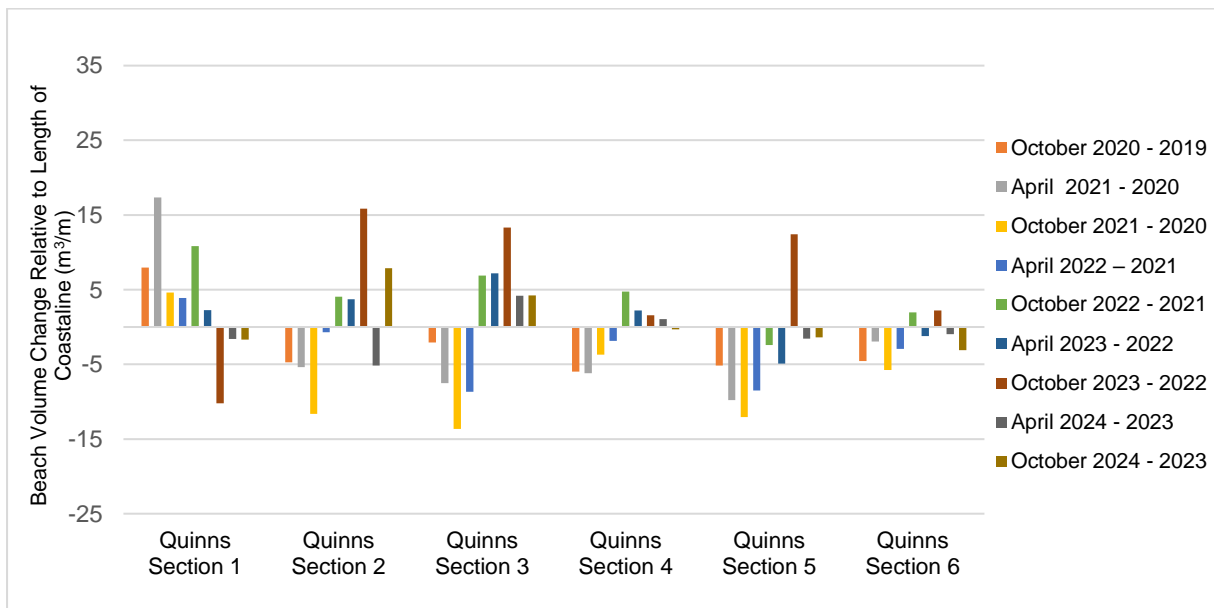
Figure 5-2 Annual net beach volume changes for Quinns Rocks Section 1,2,3,4,5 and 6.

study period, reversing the trend from last year. Conversely, a continued erosion trend was observed across Quinns Rocks Section 1. Nourishment works were undertaken within Quinns Rocks Section 3 (3,000 tonnes), Quinns Rocks Section 5 (2,000 tonnes), and Quinns Rocks Section 6 (2,000 tonnes). Figure 5-2 shows a continual reduction in beach volume within Quinns Rocks Section 5, even with the renourishment works. The City has placed approximately 10,000 m³ of sand within this beach section since 2020 as part of the City's ongoing Beach Renourishment Program and has recently started to undertake regular nearshore beach scraping at this site since 2023. It is recommended that this site continue to be closely monitored as Ocean Drive, associated public infrastructure and residential housing is located less than 100m from the base of the dune and could be impacted by continued coastal erosion.

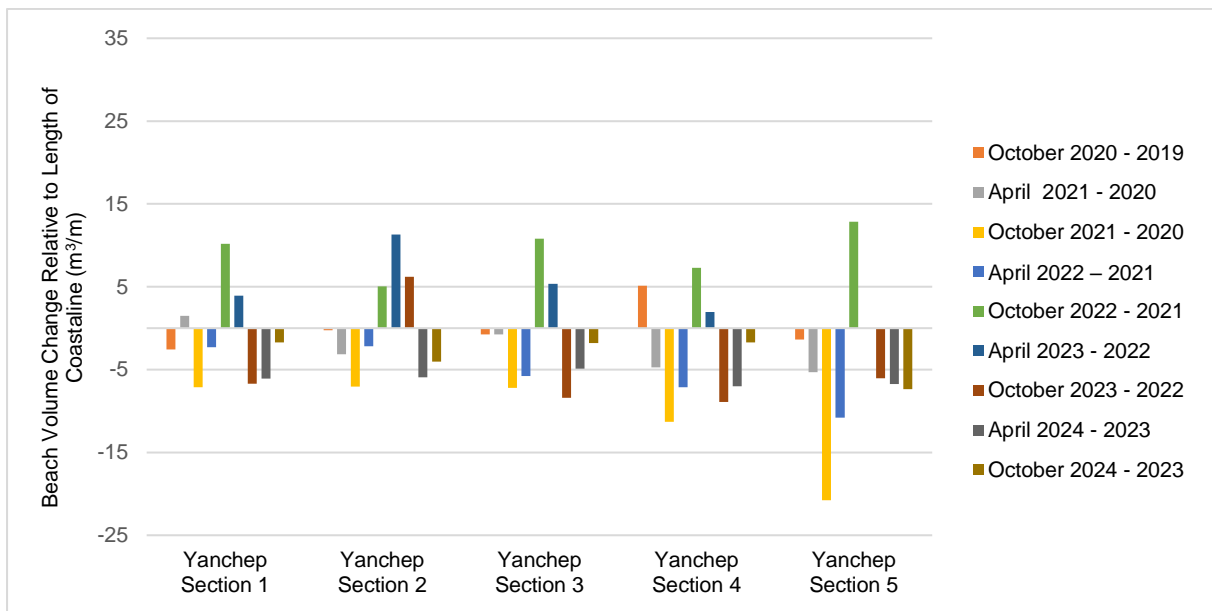
Figure 5-3 Annual net beach volume changes for Yanchep Section 1,2,3,4 and 5.

There was continued loss in beach volume across Yanchep between October 2023 and October 2024 in all sections. It is possible that this is a result of strong summer sea breeze conditions transporting sediment further north, away from the Yanchep coastline, however further analysis is required to better understand sediment transport along the Yanchep coastline. It is anticipated that additional data collection and numerical sediment transport modelling undertaken as part of the Yanchep Coastal Management Study will improve our understanding of sediment transport processes in this area.

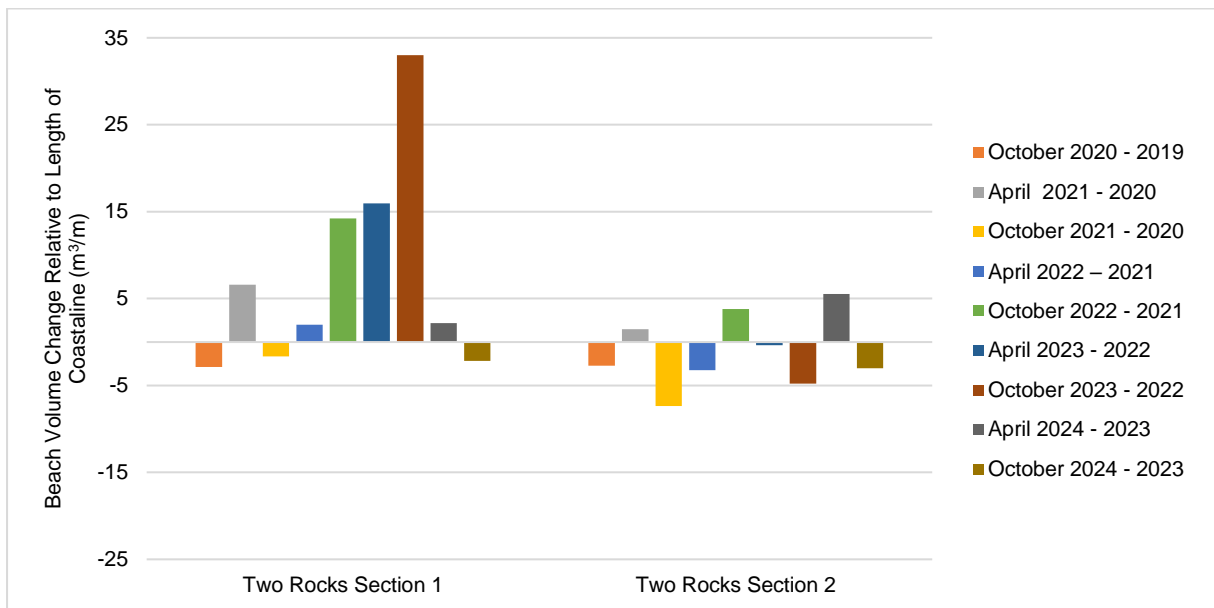
Figure 5-4 Annual net beach volume changes for Two Rocks Section 1 and 2.

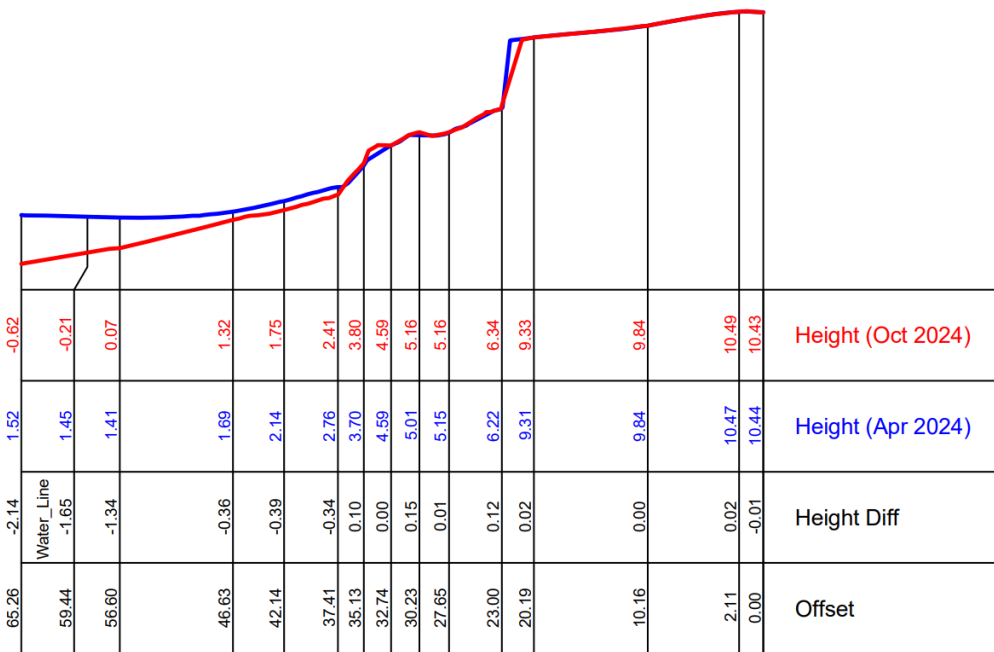
Cross Section 14 – Manual Imagery Site B07 Down-Coast

Figure 5-7 Quinns Rocks beach cross section 14 elevation comparison between April 2024 and October 2024 surveys.

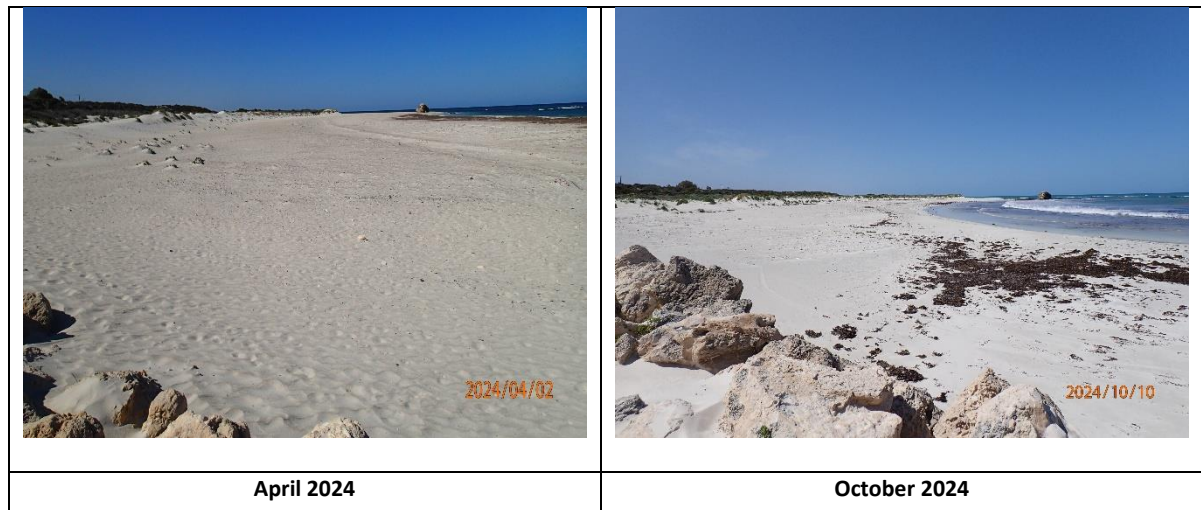
Figure 5-12 Manual imagery taken at Two Rocks B05 Down-Coast in April 2024 and October 2024

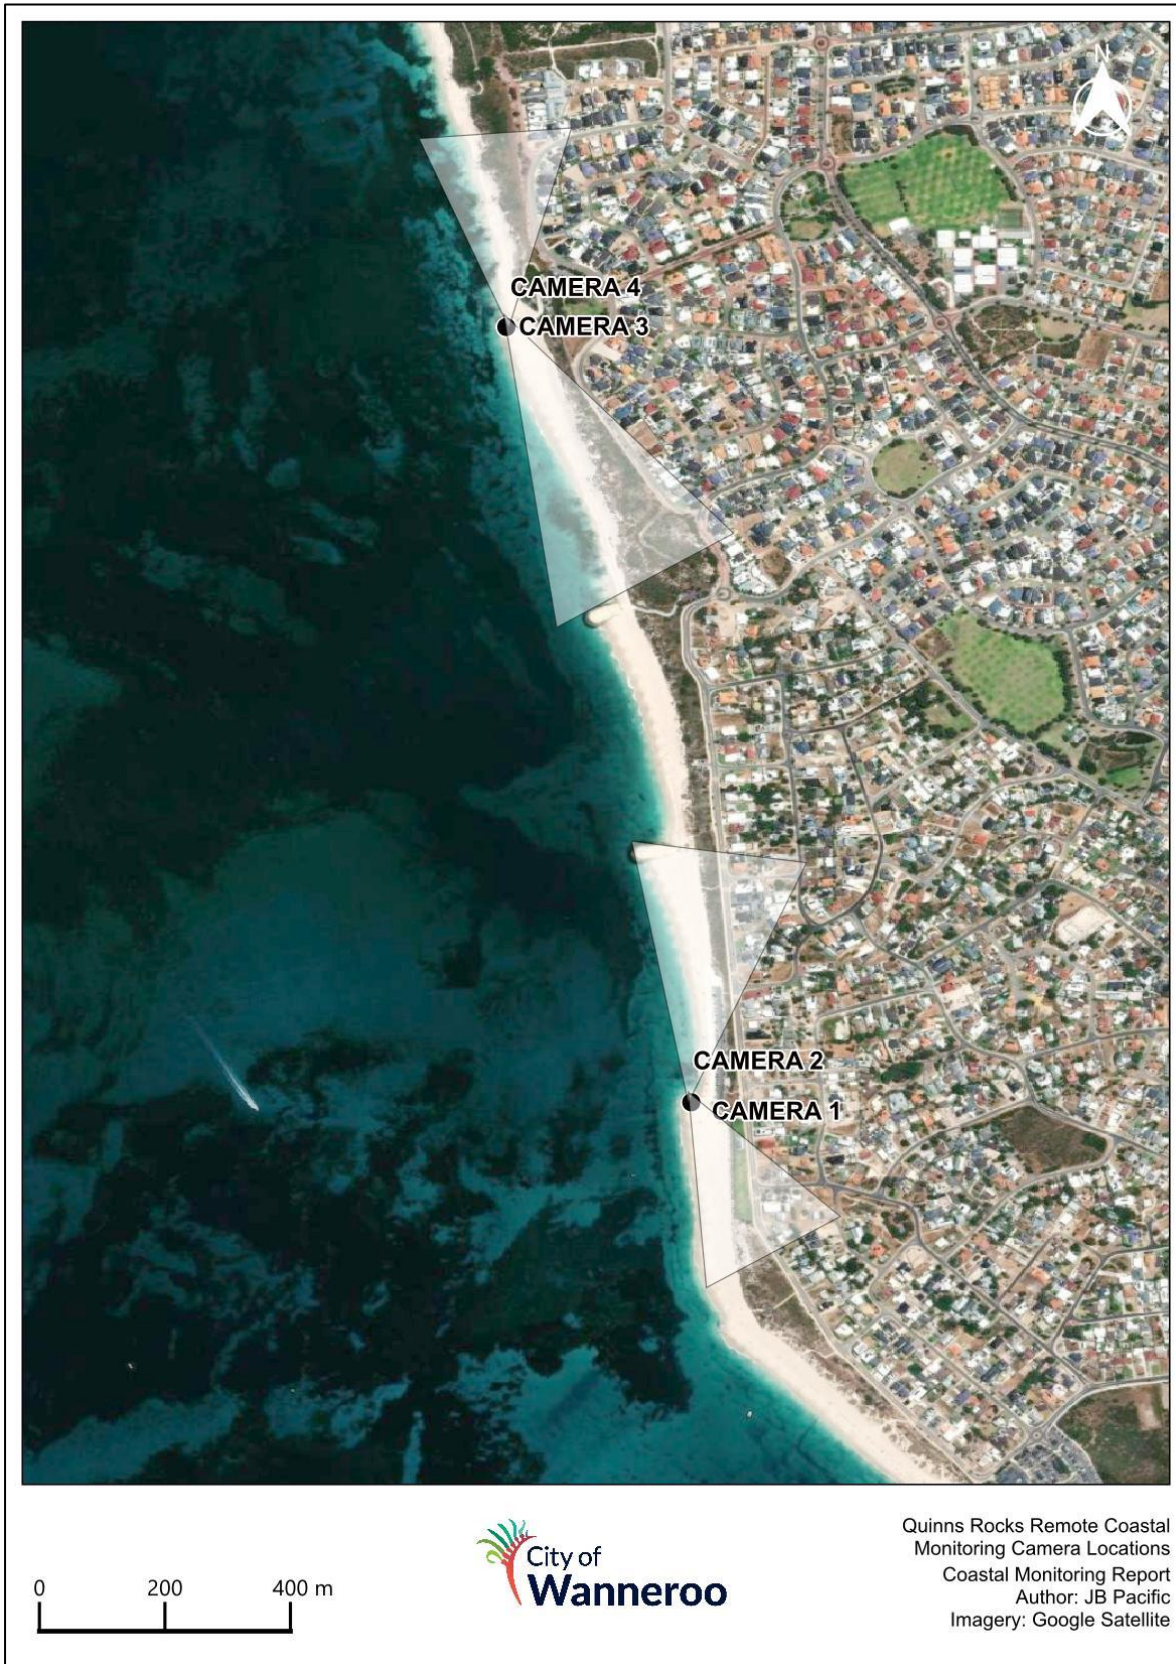
Five remote monitoring cameras were installed along Quinns Rocks and Yanchep Beach in November 2021. The location and field of view of the cameras was selected to monitor vulnerable sections of the City's coastline, these locations are presented below in Figure 6-1 and Figure 6-2. The cameras take photos hourly between the hours of 7:00 and 18:00. Timelapse videos were created for each camera to assess morphological changes to the coastline between October 2023 and October 2024.

Quinns Rocks Remote Coastal Monitoring Camera Locations

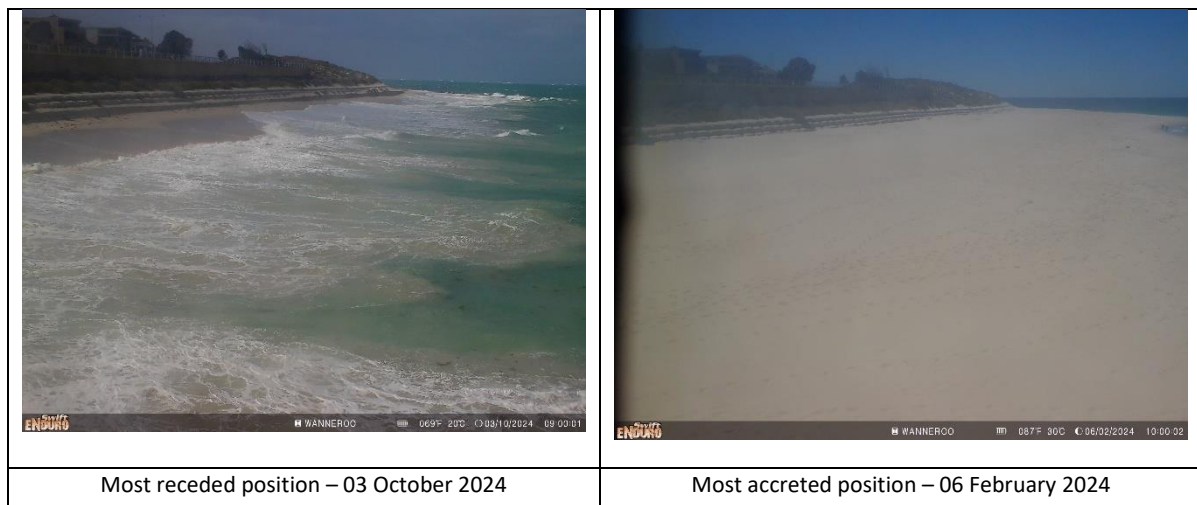
The time series of images taken from Quinns Camera One (1) between November 2023 and October 2024 shows a wider beach from December 2023 up until May 2024. After May 2024, the beach begins to erode and continues to erode until end of the monitoring period in October 2024. This section of coastline is at its most receded position 3 October 2024, shown in Figure 6-3. Erosion is attributed to winter storms which mobilise sediment away from the beach face and transport sediment southward.

Figure 6-3 Most receded and most accreted shoreline positions to the south of Quinns Rocks Groyne One (1) during the study period.

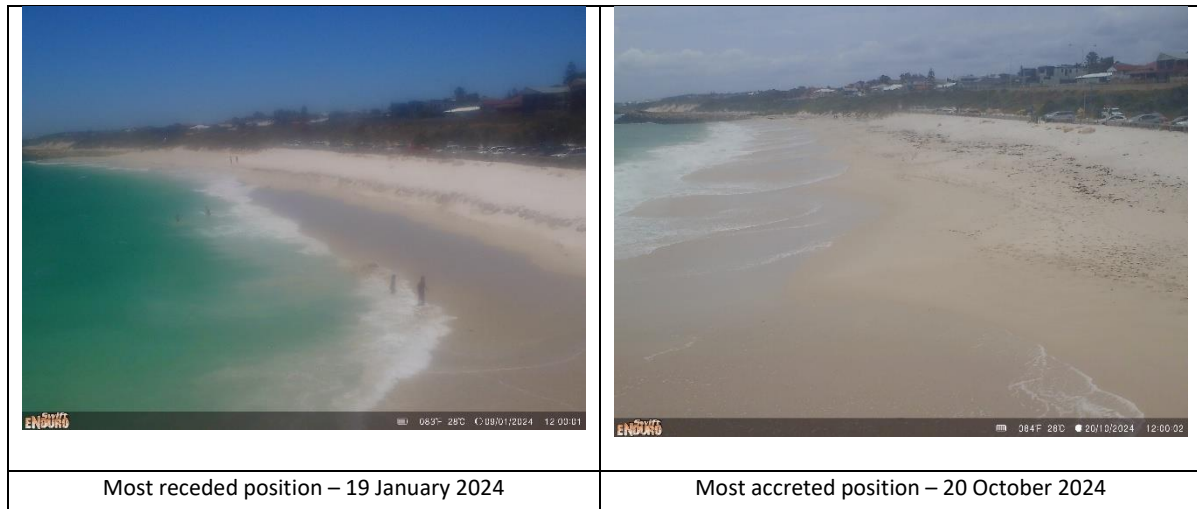
Quinns Rocks Camera Two (2) captures the beach immediately north of Groyne One (1), adjacent to the Frederick Stubbs Carpark. Hourly images from the camera show the beach eroding over December 2023 throughout January. Accretion of the beach in the summer period is not expected, as prevailing southerly to south-westerly winds generally transport sand north where it is deposited to the south of the Groyne Two (2). It is believed that the build up to the south of Groyne has resulted in bypassing of sand around Groyne and onto the beach, adjacent to the carpark. The city undertook nourishment in front of the carpark in May 2024, where 3000 tonnes of sand was placed at the beach to provide a buffer against the impact of winter storm events and create a safe and accessible beach for the public.

Figure 6-4 Most receded and most accreted shoreline positions to the north of Quinns Rocks Groyne One (1) during the study period.

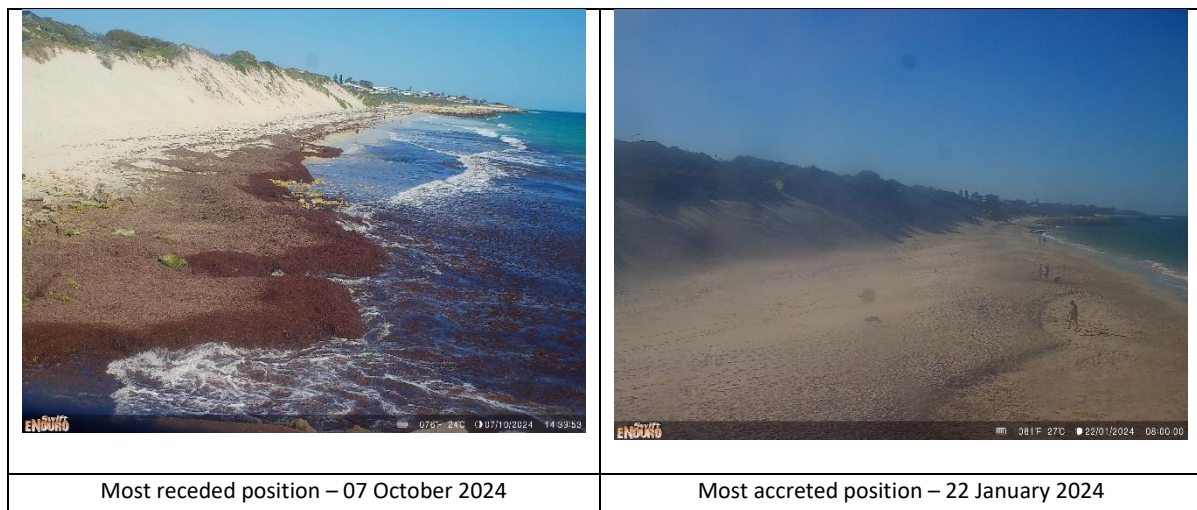
Quinns Rocks Camera Three (3) monitors the beach and dunes to the south of Quinns Rocks Groyne Four (4). Hourly images of the site show slow steady accretion of the beach from the start of the monitoring period until January 2023 where the beach then begins to erode. The most receded shoreline position was observed in October, just following a minor storm event, which resulted in exposure of limestone bedrock on the beach. Beach scraping was undertaken at this site in December 2023 where sand that had built up to the south of Groyne Four (4) was taken from the nearshore and used to create a buffer at the base of the dunes.

Figure 6-5 Most receded and most accreted shoreline positions to the south of Quinns Rocks Groyne Four (4) during the study period.

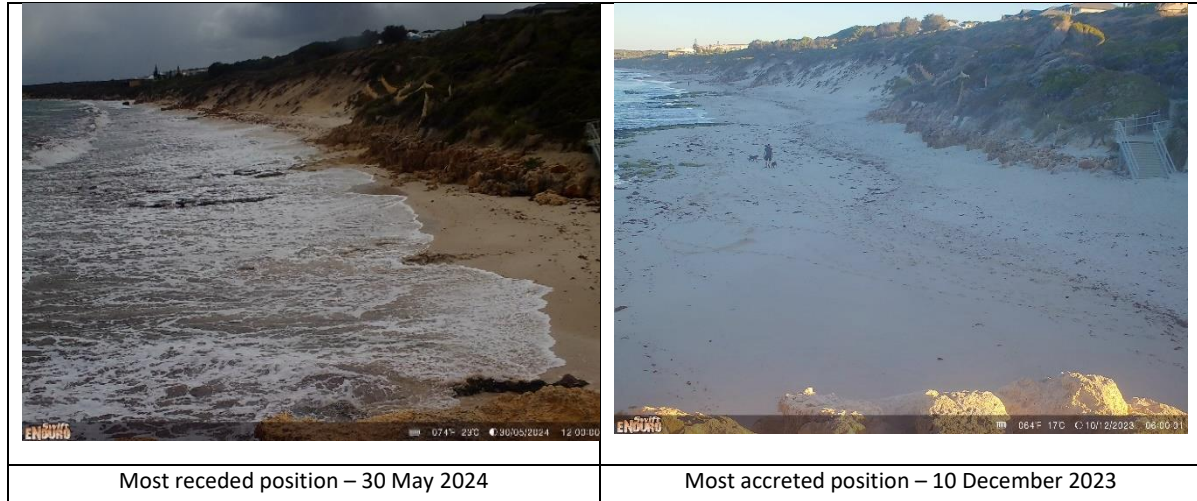
events transport sand southward where it builds up against the Groyne. Again, this seasonal trend is expected for this site.

Figure 6-6 Most receded and most accreted shoreline positions to the south of Quinns Rocks Groyne Four (4) during the study period

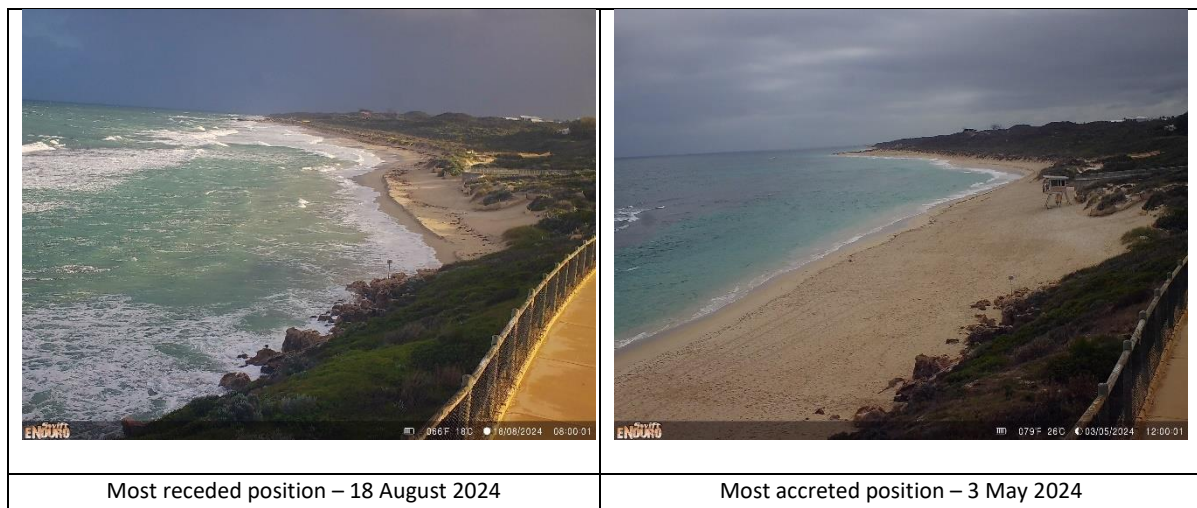
The Yanchep Camera captures hourly images of Yanchep Lagoon Beach, which is bound by a rocky headland to the south and a small rock groyne to the north with a fringing reef system in the nearshore. During the summer the beach is wide and accessible, particularly to the south, however throughout the winter period the beach to the south is eroded by winter storm events that mobilise sediment away from the beach face. The beach was at its most receded position in August 2024 as per Figure 6-7.

Figure 6-7 Most receded and most accreted shoreline position at Yanchep Lagoon Beach.
