CLUBROOM RENOVATION

MONTROSE PARK
C/O MONTROSE AVE & MIRRABOOKA AVE,
GIRRAWHEEN, WA 6064

FLOOR PLAN

DRAWING No.	SHEET	REVISION	ORIGINAL DRG. SIZE
4188.135	I	A1

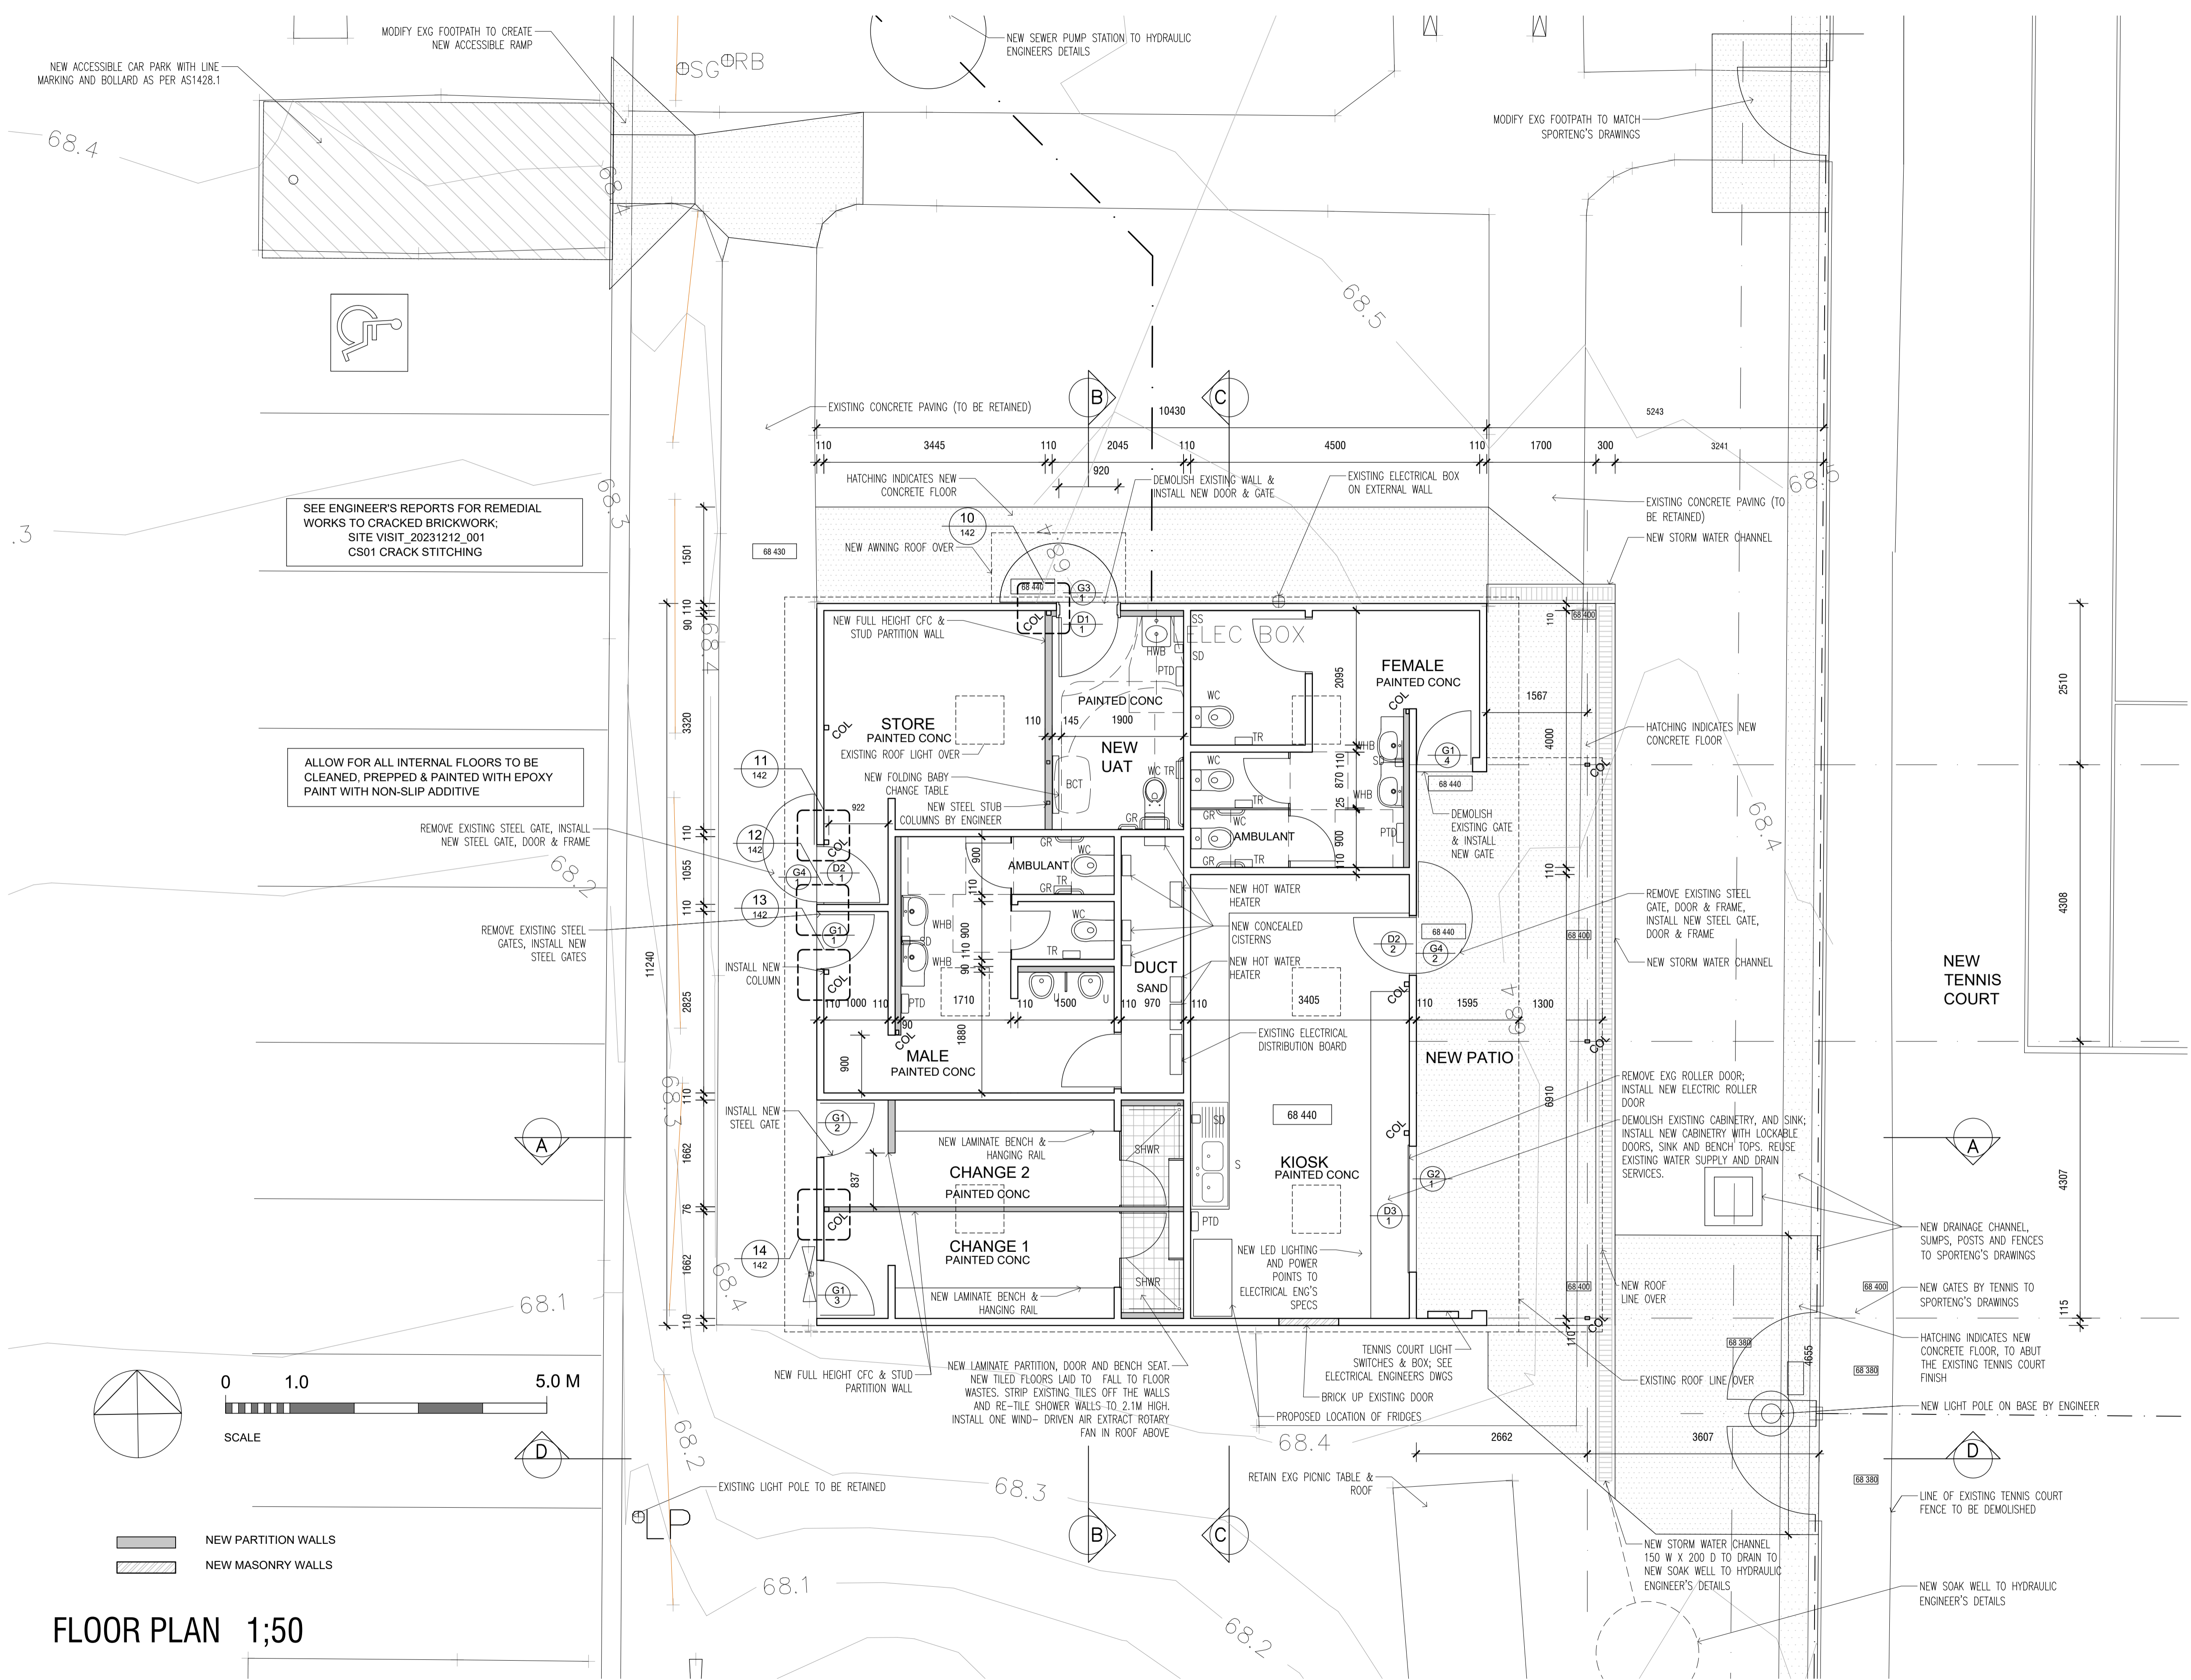
FLOOR PLAN 1:50

SEE ENGINEER'S REPORTS FOR REMEDIAL WORKS TO CRACKED BRICKWORK; SITE VISIT_20231212_001 CS01 CRACK STITCHING

ALLOW FOR ALL INTERNAL FLOORS TO BE CLEANED, PREPPED & PAINTED WITH EPOXY PAINT WITH NON-SLIP ADDITIVE

REMOVE EXISTING STEEL GATE, INSTALL NEW STEEL GATE, DOOR & FRAME

REMOVE EXISTING STEEL GATES, INSTALL NEW STEEL GATES
